Joint Radio Company Ltd

Tappaghan Wind Farm County Fermanagh, Northern Ireland

28 June 2006

Analysis of the interaction between Wind Turbines
and Radio Telemetry Systems
based on tests conducted on 29 March 2006

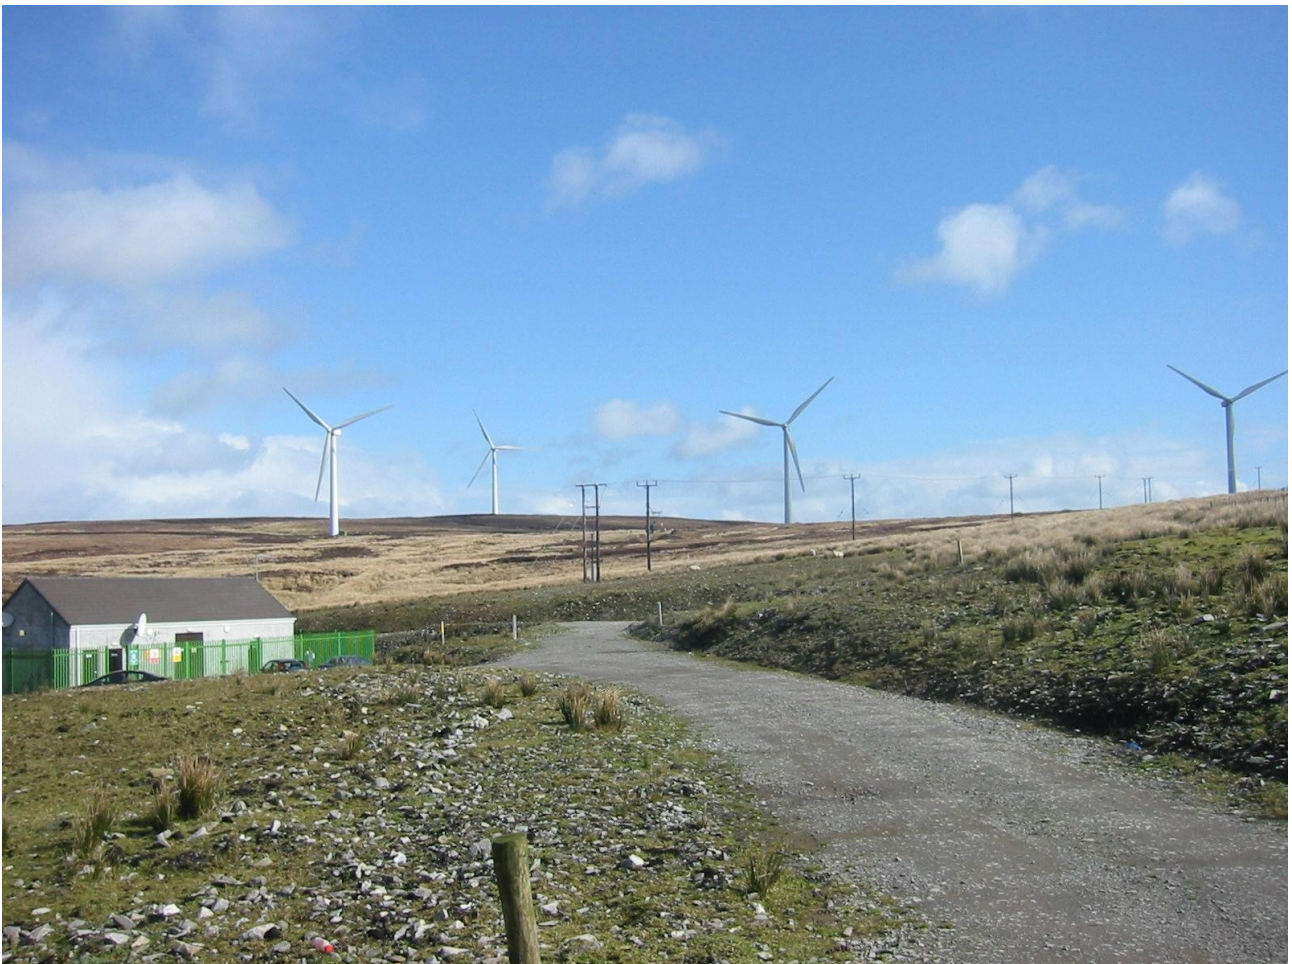
Figure 1 - General view of Tappaghan wind farm control room/sub station and the four closest turbines.

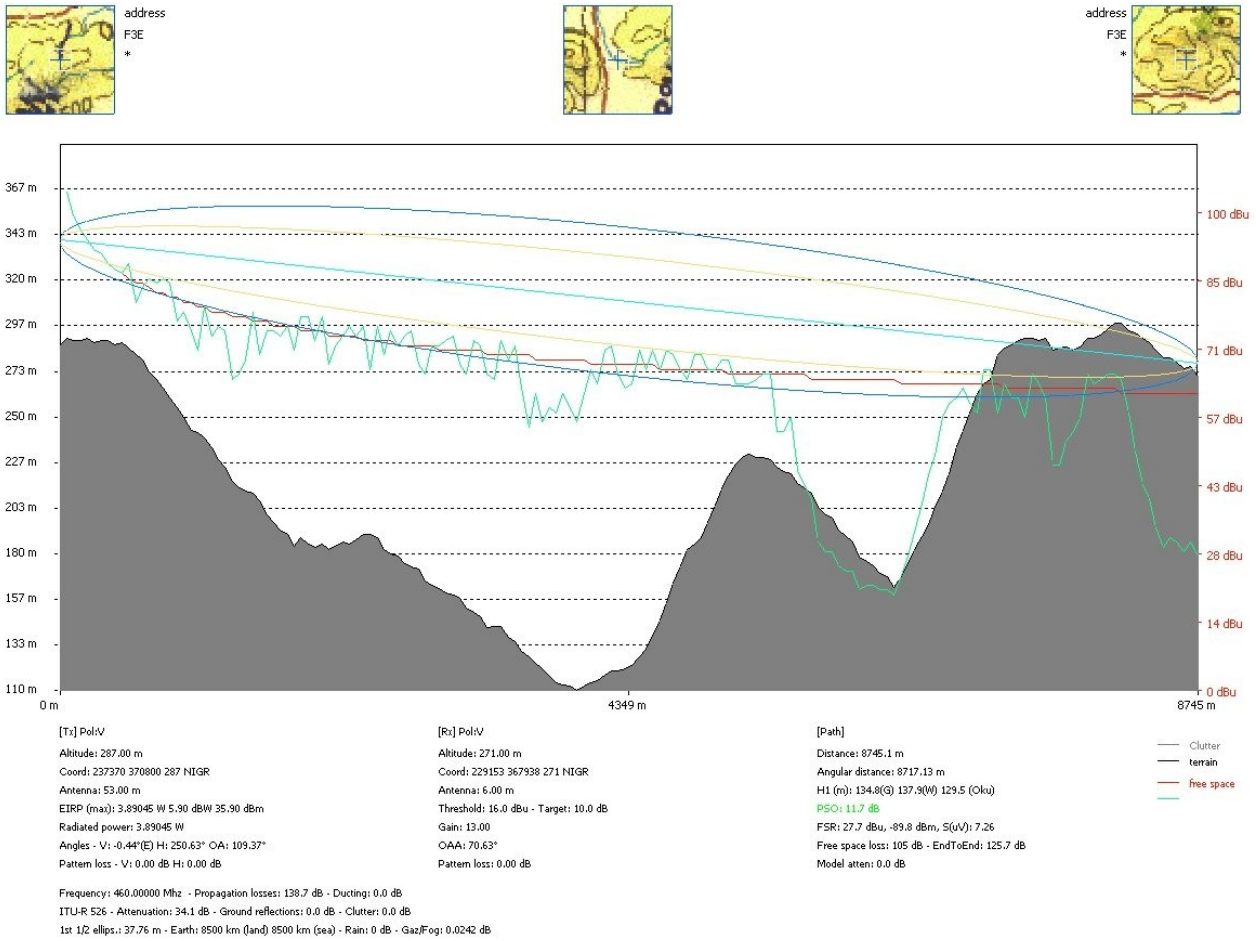
Figure 3: Path profile and analysis of the link from Pollnalaght to Tappaghan.

(34) The predicted path loss for this link is 104.6 dB FSL plus 34.1 dB intrusion loss making a total loss of 138.7 dB. using ITU-r 525/526 algorithm. This does not include any scanner aerial clutter loss.

- The Scanner TX output is 30 dBm the EIRP for the scanner is 35.9 dBm
- The projected Rx Signal at Tappaghan is -89.8 dBm
- The outstation TX output is 37 dBm the EIRP is 50 dBm
- The projected RX at signal at Pollnalaght is -82.8 dBm
- The radio equipment installed at Pollnalaght is an unprotected MDS 4790M
- The radio equipment installed at Tappaghan is an MDS 4710.

(31) The details of the link (shown in Figures 3 & 4) are as follows:

- Pollanaght. i E237370 N370800. Aerial; Jaybeam 7356 Omni Co-Linear Aerial Height; 53m
- Tappaghan i E229153 N367938. Aerial; Jaybeam 7014 12 Element Yagi Aerial Height; 6m

(36) This path is a non-line-of-sight diffracted path but within the 143 dB maximum path loss criteria as laid down in OFW 49. The projected receive signal is above the -92 dBm set down in the same document. The closest turbines have a line of site path to both ends. This is the type of scenario that JRC believes amplifies the problems associated with wind turbines to UHF links (and UHF television).

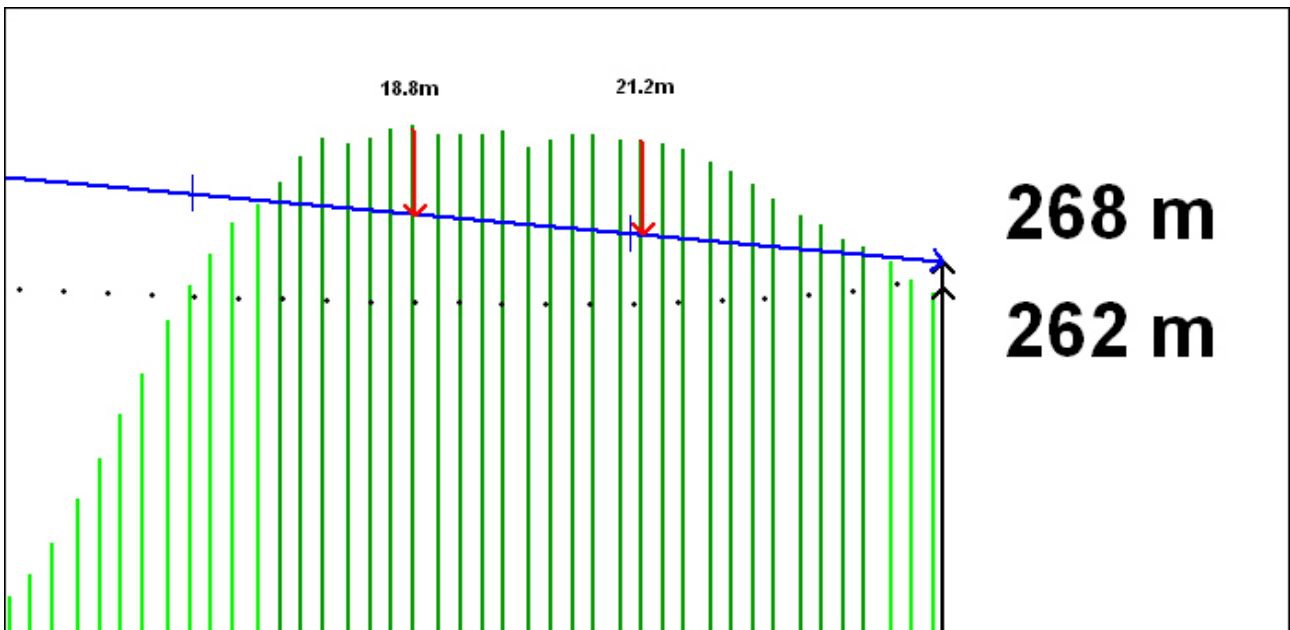
Figure 4: Expanded profile close to the outstation

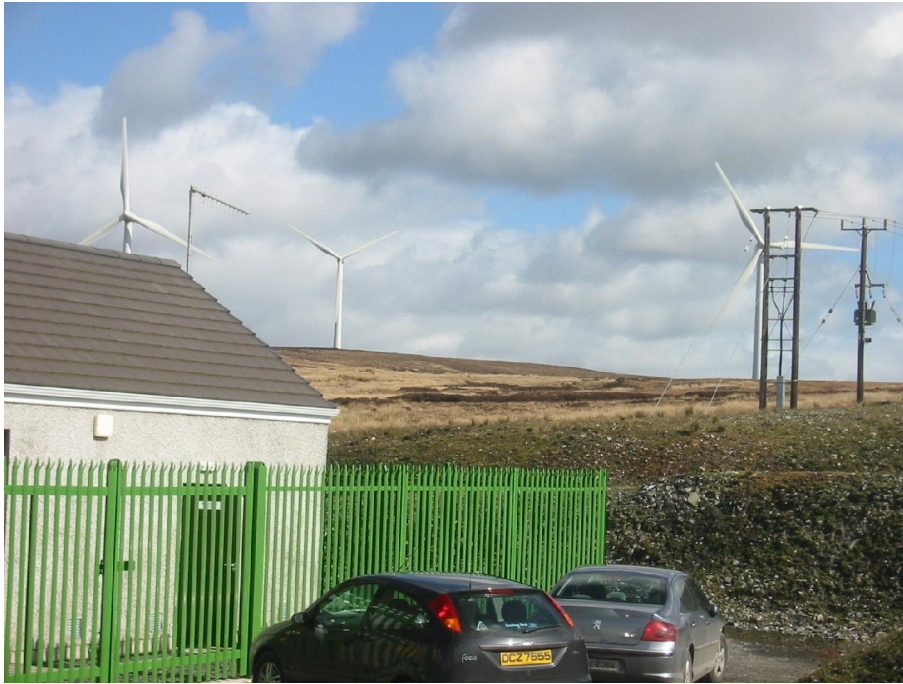
Figure 5 - View of turbine direction in relation to the link.

Note: Turbine 9 is next to the power feed.

- (38) The ray has in excess of 2 Fresnel zones clearance from the turbine tower. Any effect on the link will be caused by the turbine blades.
- (39) If the wind direction was the same as the link then the turbine blades would be 90 degrees to the link and this would be the worst case from a clearance point of view. The anemometer mast was not operational on the day of the visit so wind direction is not known accurately. JRC has subsequently obtained data from Lough Hill wind farm 8 km away at 10 minute intervals. This indicates a wind direction of between 204.9 and 249.9 degrees EIGN (223.7 average of all samples) at a wind speed of 3.2 to 13.3 m/s between 13:30 and 14:30 hrs (GMT +1). If this is so the turbine will be presenting a horizontal profile to the link of between 0.7 and 1.0 (0.89 average) of the rotor diameter. From the pictures taken prior to the test, the wind appears to be coming **about** 30 degrees off of the direction of the link aerial. The turbines appeared to be synchronised and operating at normal rotational speed.

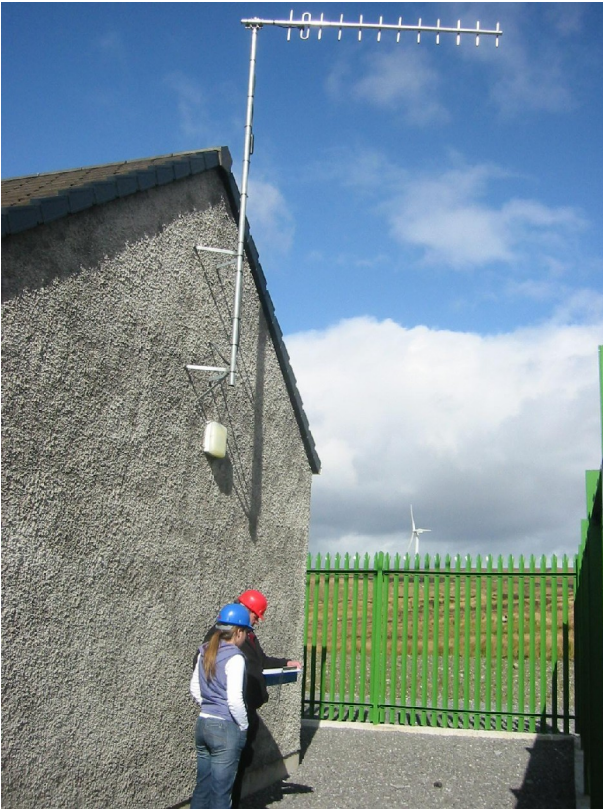
Figure 6 - The aerial at Tappaghan.

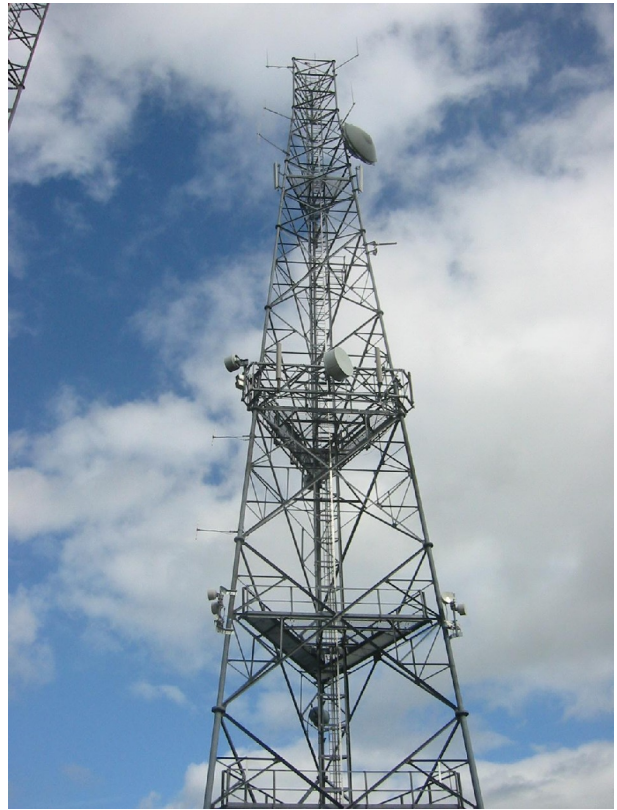
Figure 7 - The mast at Pollnalaght. The UHF co linears are at the top of the mast.

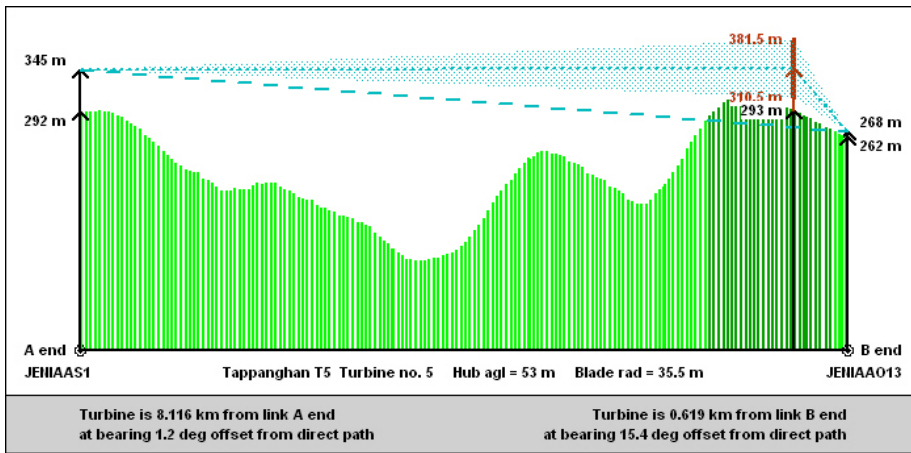
Figure 10 - Path profile of the link in relation to turbine 5.

- (41) The two next closest turbines to the link path are Turbine 5 (164 m horizontal clearance) and Turbine 10 (256 m horizontal clearance) – with no allowance for uncertainty.

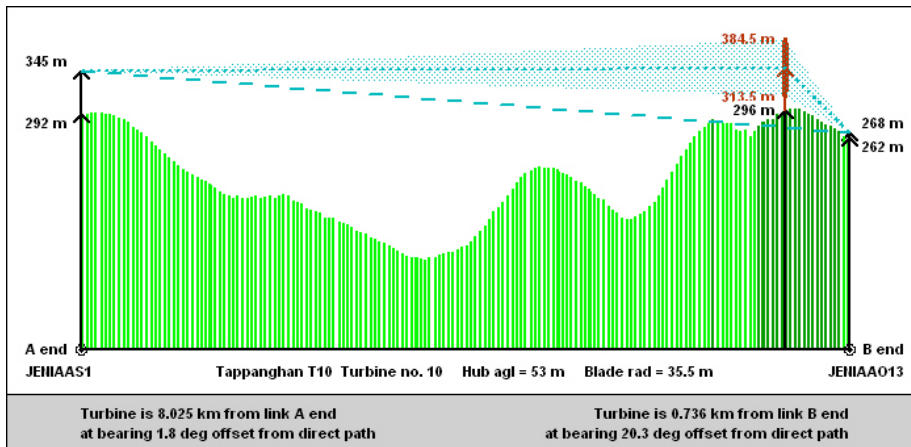
Figure 12 - Path profile of the link in relation to turbine 10.

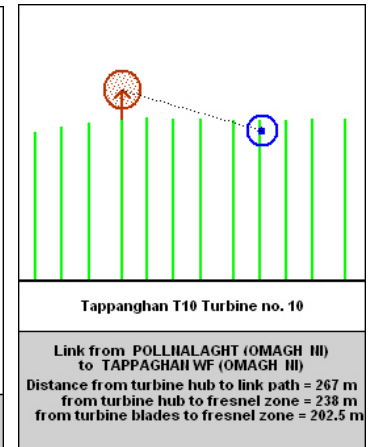
Figure 13 – Schematic relationship of turbine 10 to the ray.
